Today's Deep Restoration- By John Kanca III

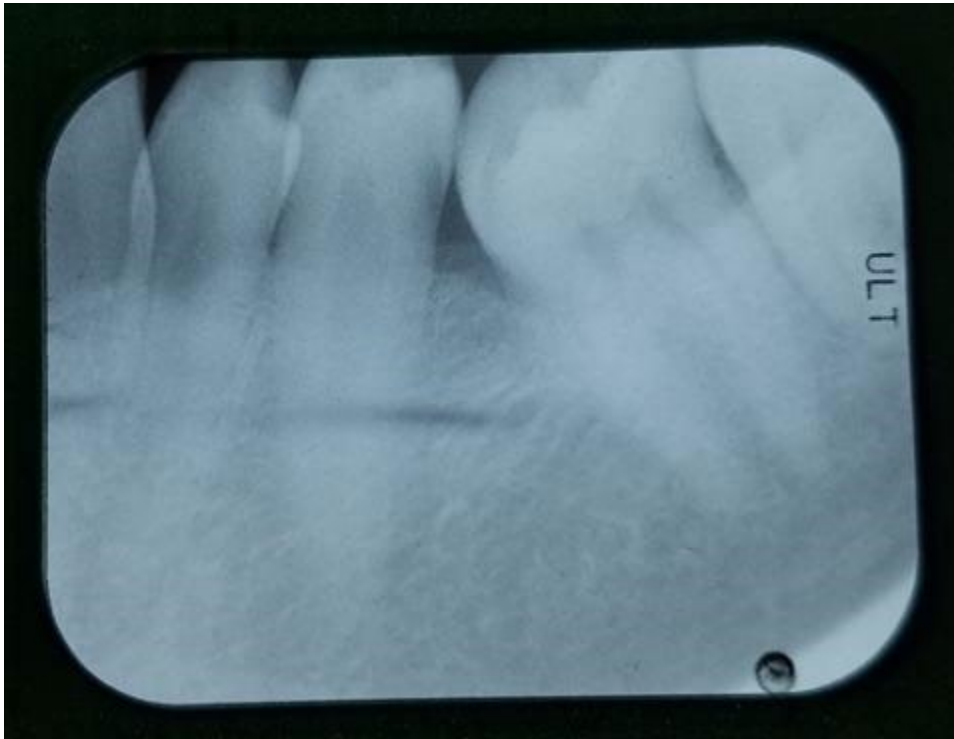
Pre-op radiograph of a deep lesion on the distal of the second bicuspid.

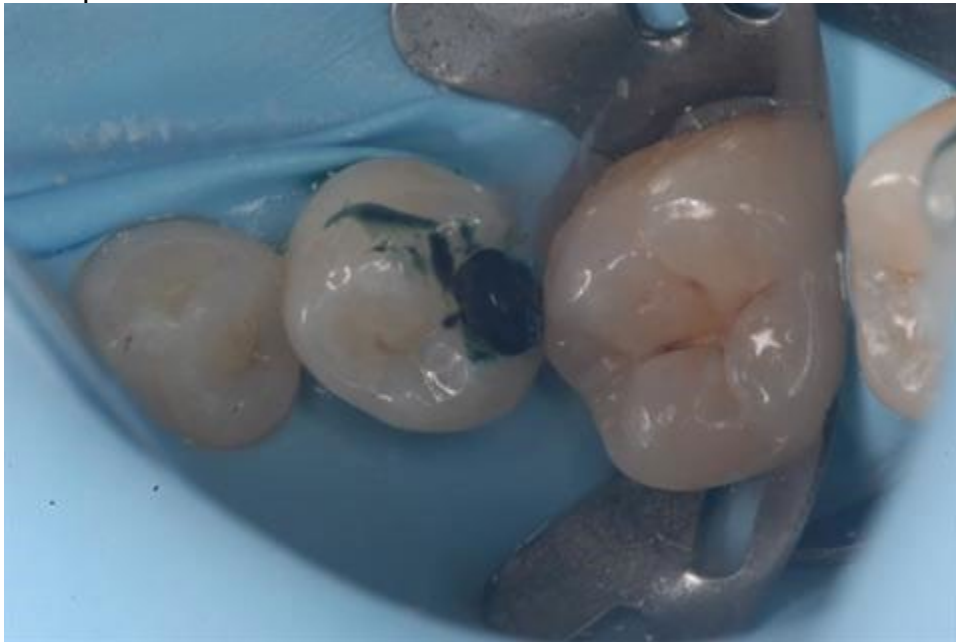
Cavity prep with staining until all decay removed.

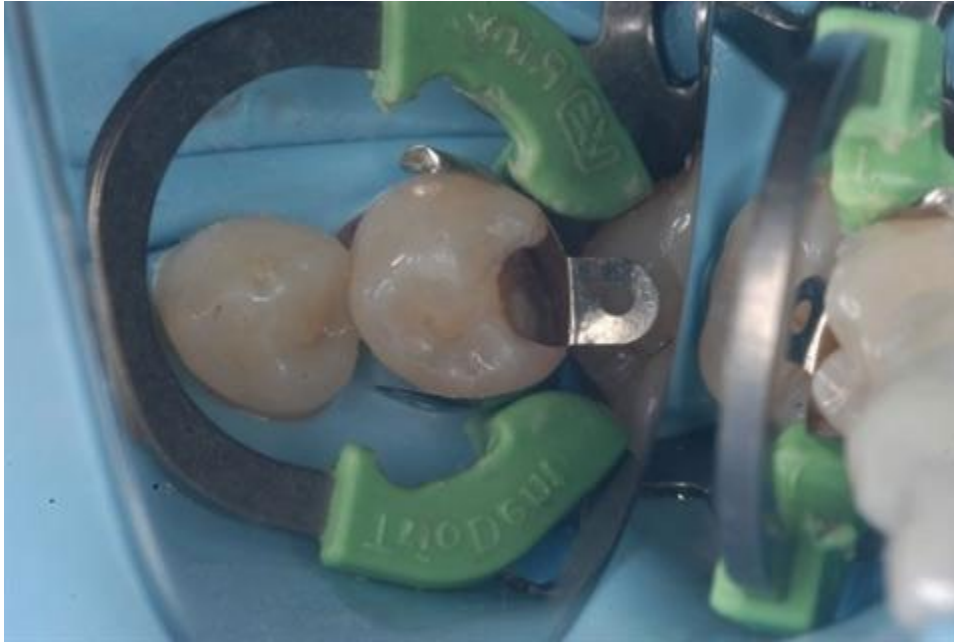
Large tab matrix, small flexi wedge, and V3 ring.

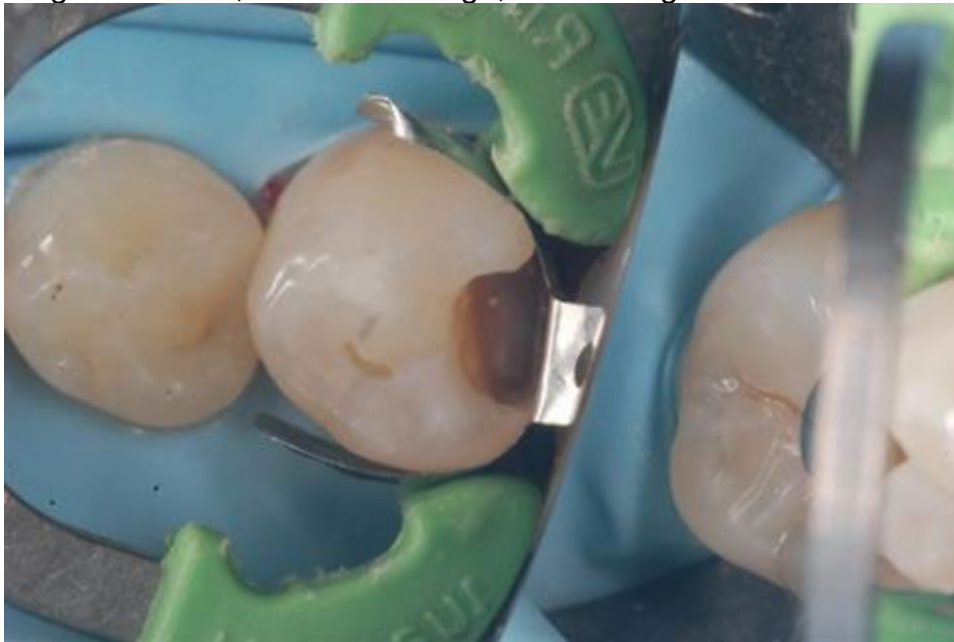
Clean and Boost for 15 seconds, rinsed and dried to demonstrate the etching ability of Clean and Boost.

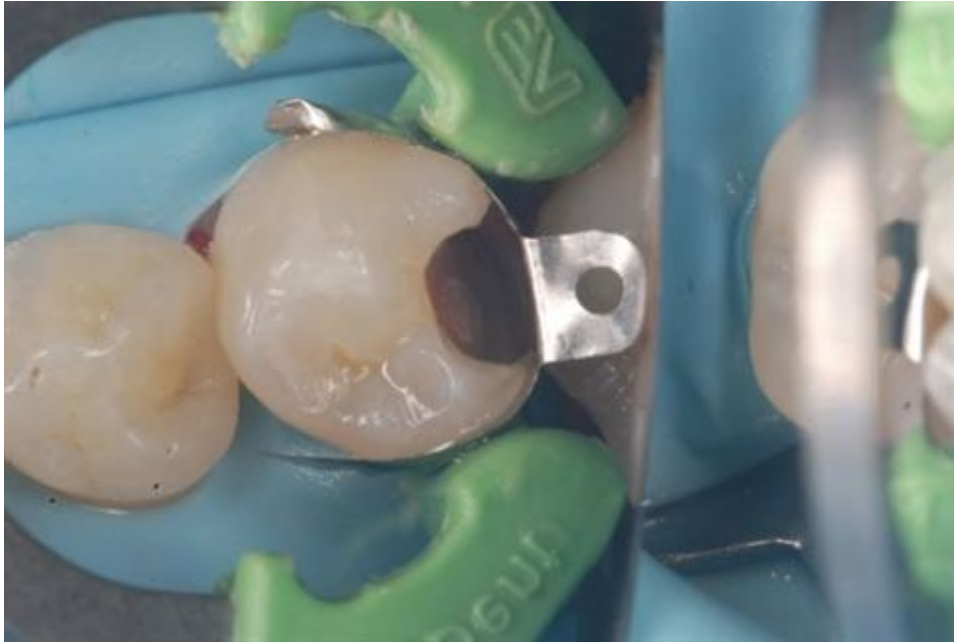
Cavity re-wetted with Surpass 1, Surpass 2 applied, completely air dried and Surpass 3 applied, air thinned thoroughly and light-cured.

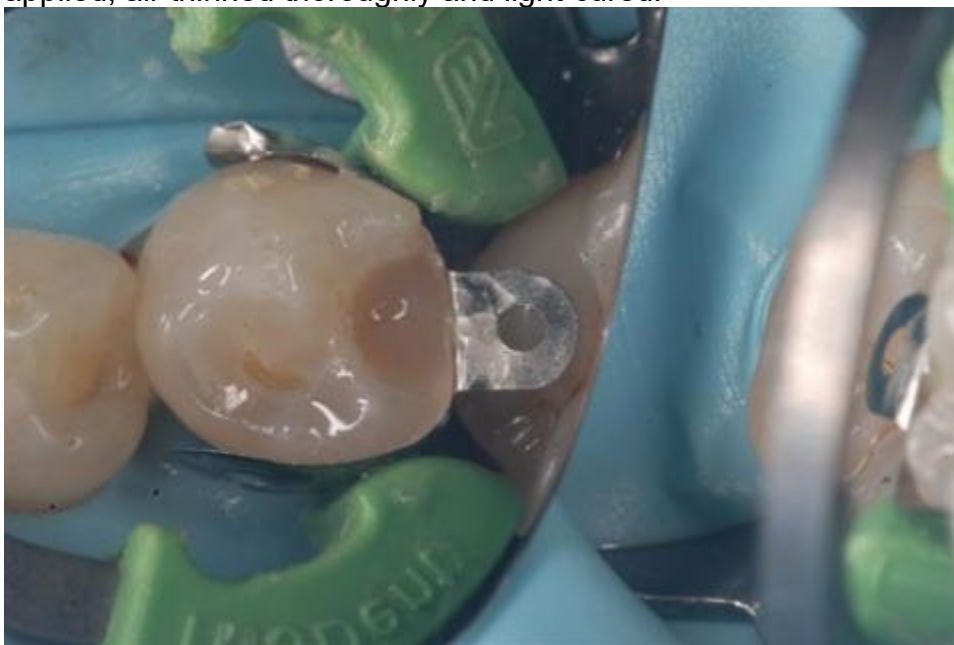
A layer of Titan flowable, a layer of Exquisite Restoration, light-cured one cycle with VALO on high power for three seconds.

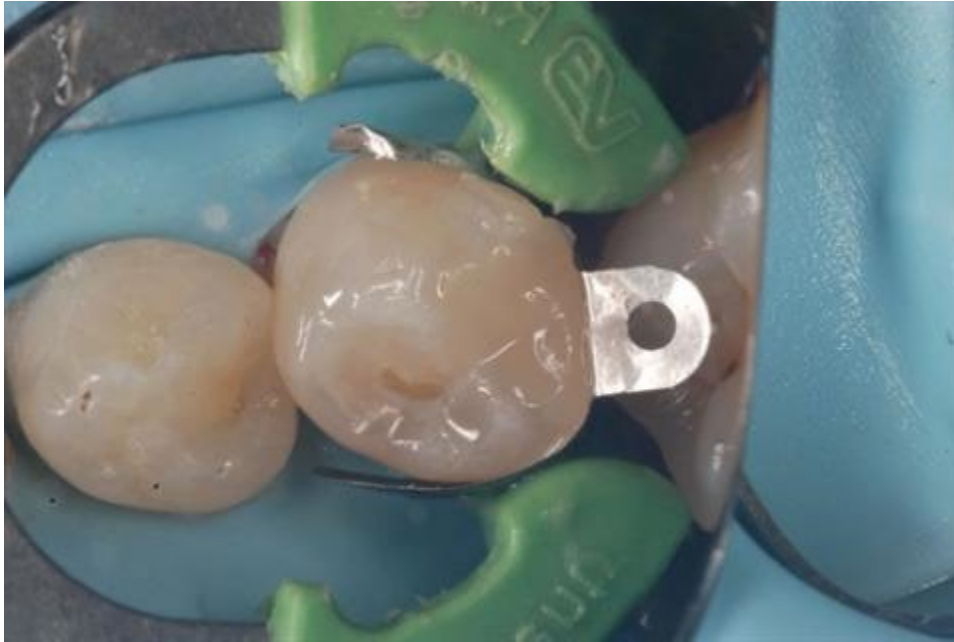
Second layer of Exquisite, Extra power 3 second cycle.

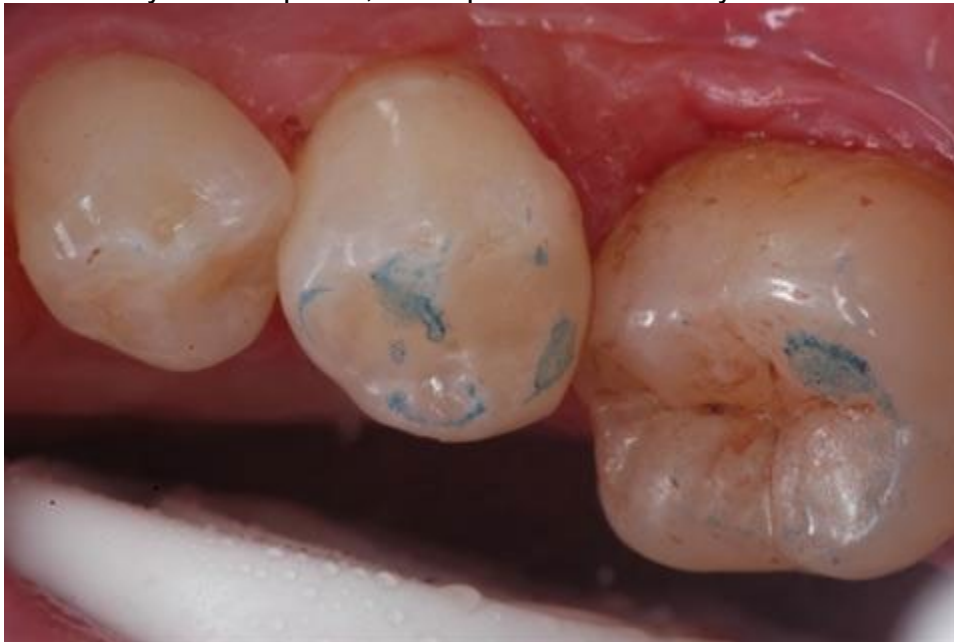
Matrix and dam removed, occlusion adjusted.

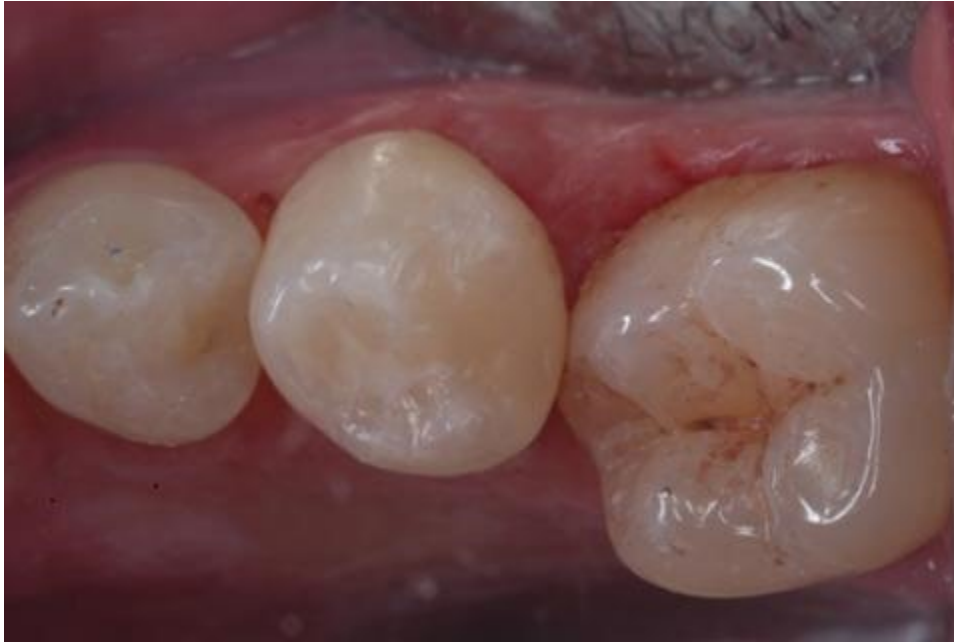
Restoration polished.

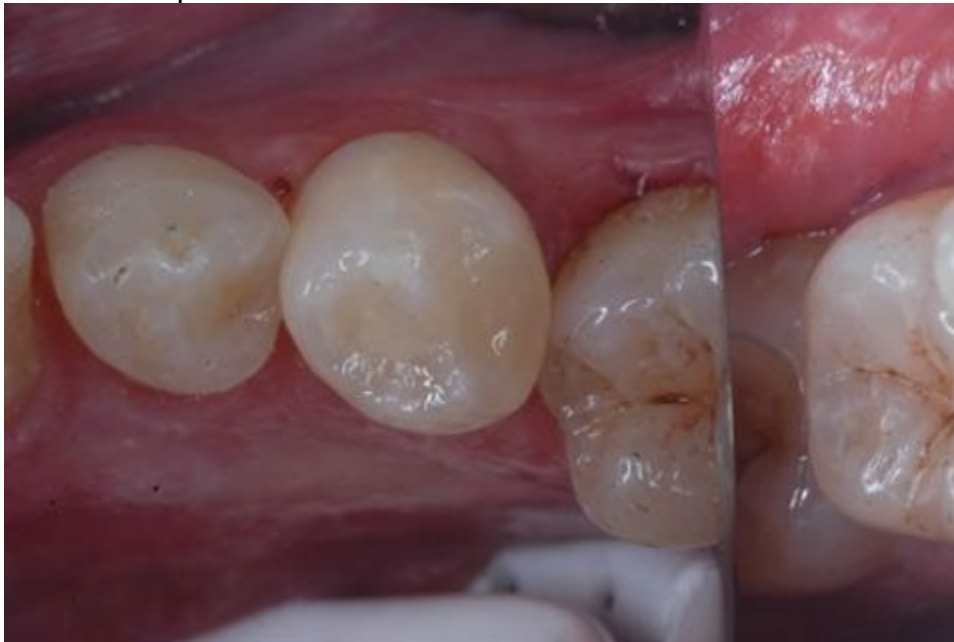
Restoration sealed with mixed Interface and Surpass 2, completely air dried, light-cured.

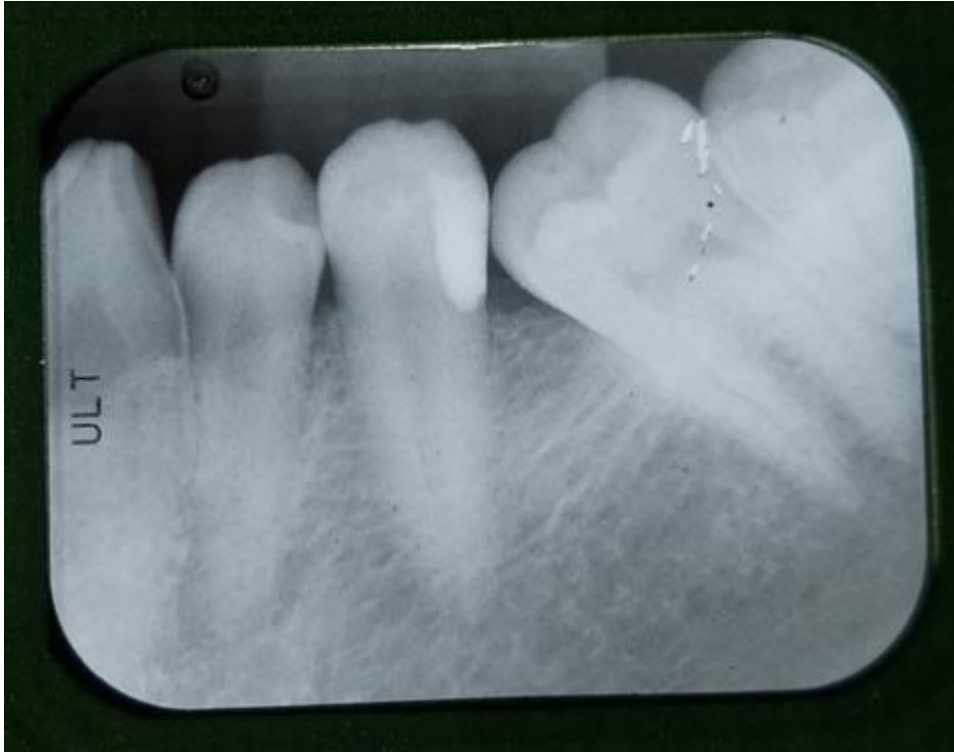
Post-op radiograph.
